TECHNICAL MANUAL for IBIS ROOFTOP AIRCONDITIONER

ERROR CODES & THEIR MEANING

TECHNICAL MANUAL for IBIS ROOFTOP CARAVAN

AIRCONDITIONER

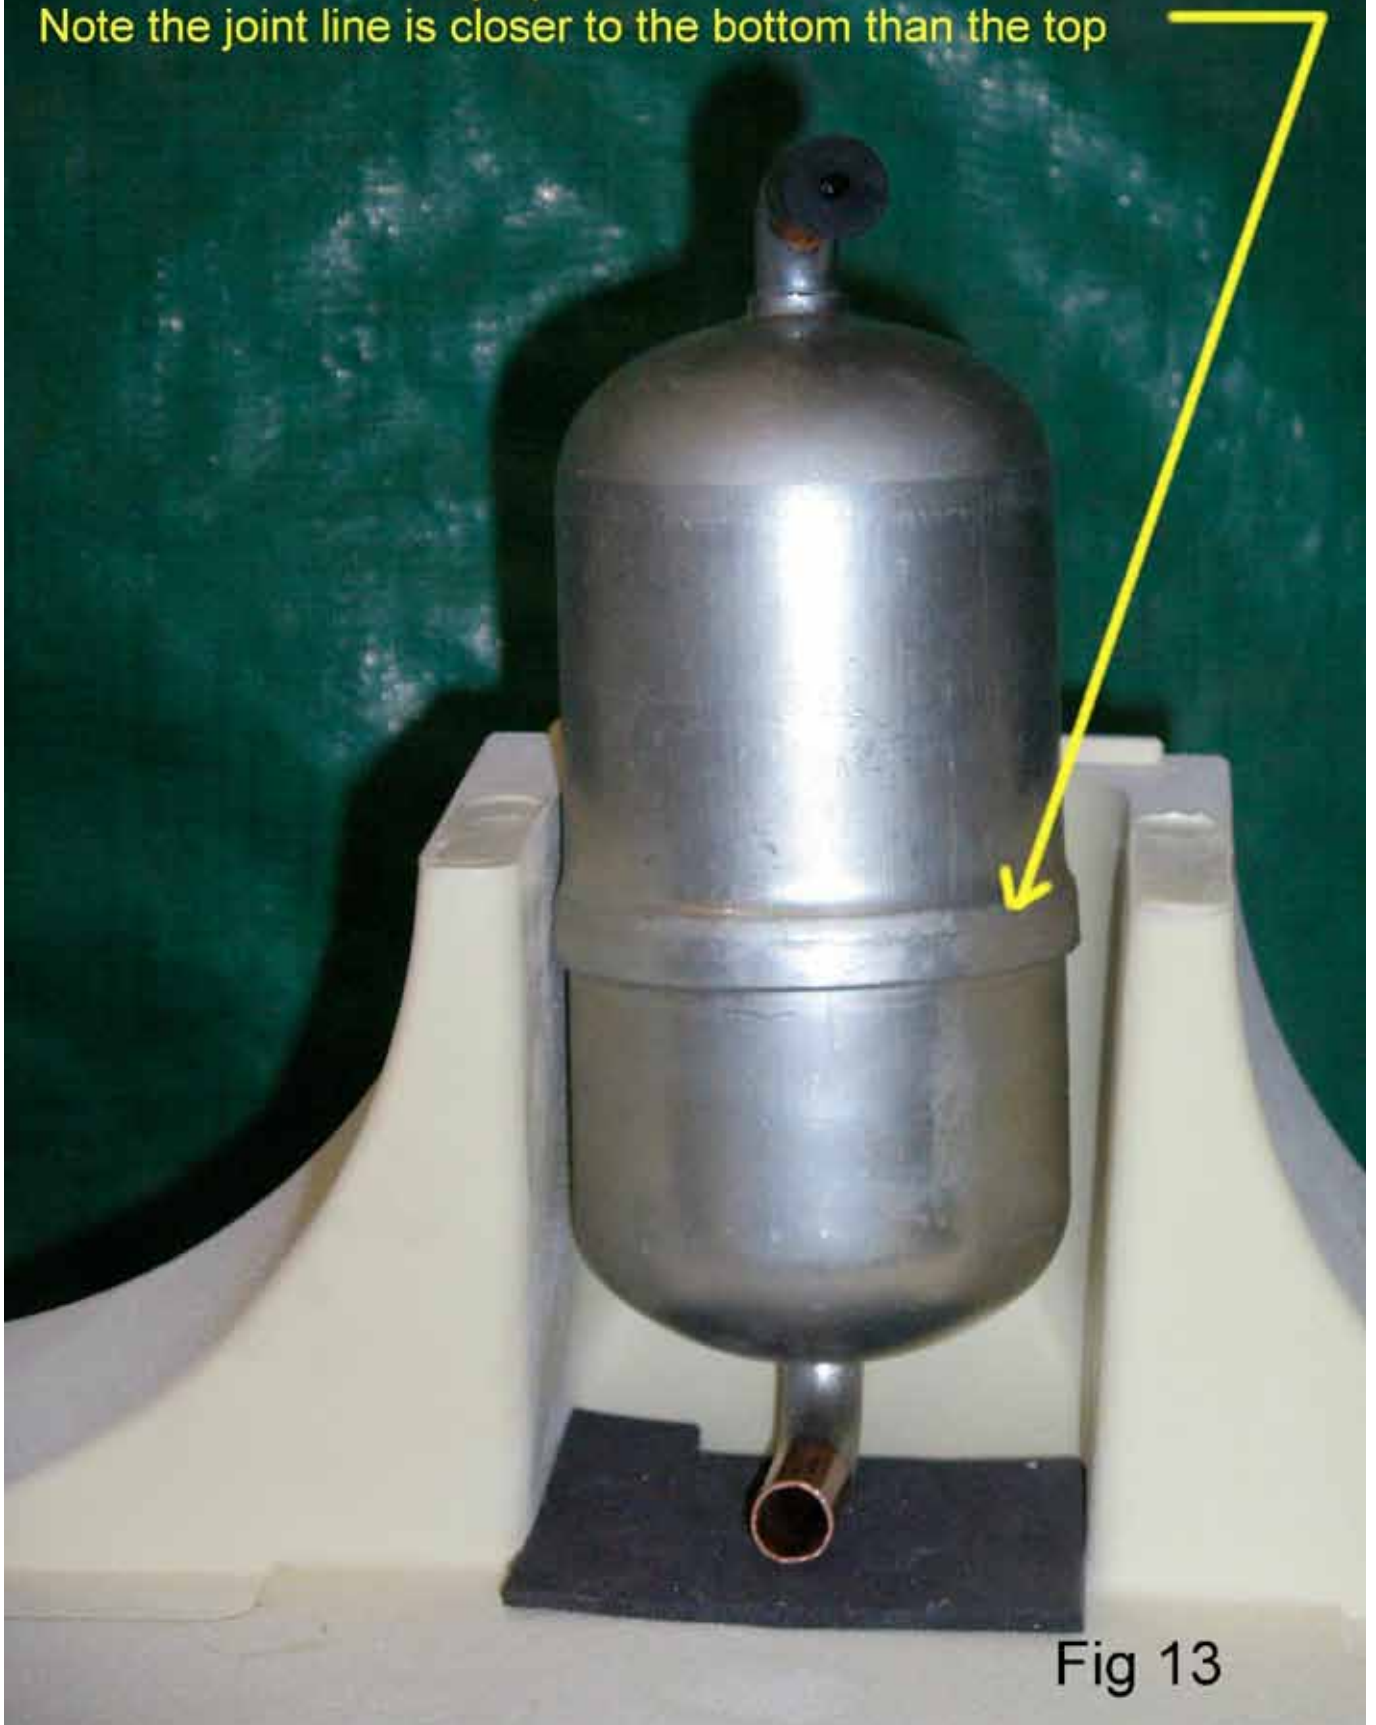
Fig 13

This is the correct way up.
Note the joint line is closer to the bottom than the top
